Figure 1 - NOAA Chart 12205

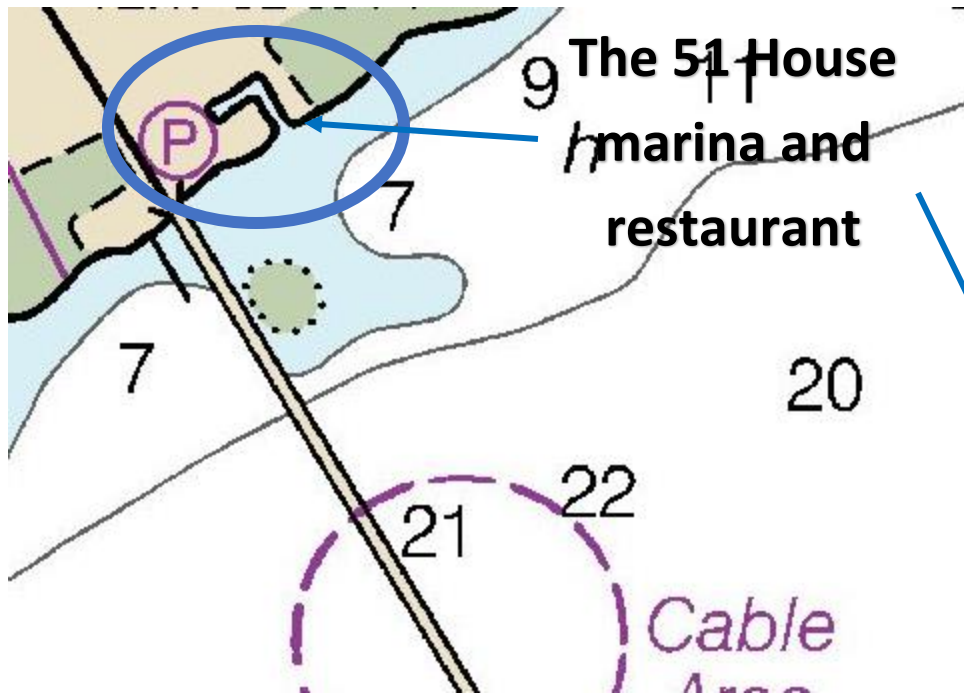
Based on information from the dredging company, the channel is 7 feet deep directly out from the boat basin. Recent surveys show a shoal just **outside the breakwater at 5.5 feet.** As with all navigation, enter the marina using good marine practices. The chart and photo presented here are not for navigational purposes but rather to give the mariner additional information for the approach to the marina.
